Manhole Inspection Summary

Manhole # S31U1_006MH

Insp Date: **4/9/09 1:27 PM**

Location Address: **598 W. Patapsco Ave.**

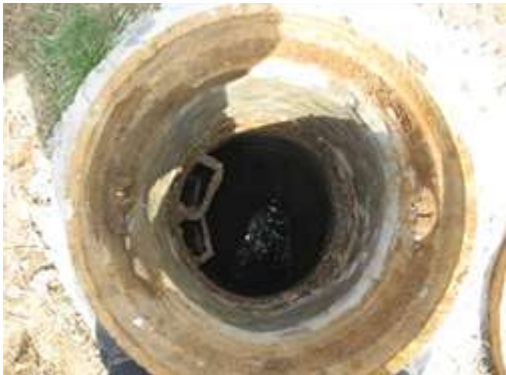
Top View

Condition: ☐ Sound ☐ Cracked ☐ Root Intrusion ☐ Deteriorated ☐ Leaks ☒ Debris

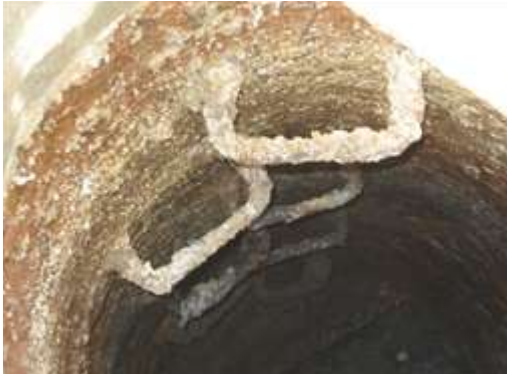
steps

Steps Count: **8** Missing: **0** ☐ Corroded

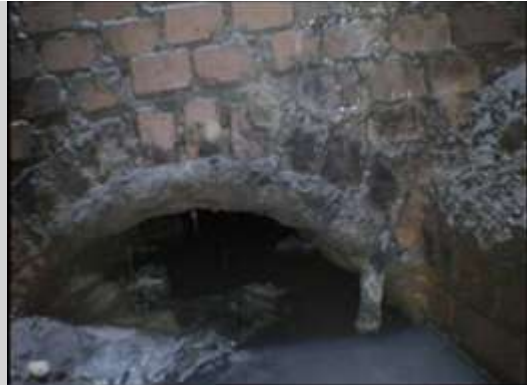
12 O'Clock Outflow

30 in. Circular Gravity Sewer
Pipe Out @ 12 O'Clock

Pipe Height: **18** (in.) Rod and Bar (Angled)
Pipe Material: **Clay** ☐ Pipe Lined
Invert Depth: **15.60** (ft.) Flow Characteristics: **Slow**
Deposits: ☐ None ☐ Mud ☒ **Sludge** ☒ **Debris** ☐ Grease
Silt Depth: **14** (in.) Deposits Extent: **Heavy**
Infiltration: **None** Pipe Seal Cond: **Sound**

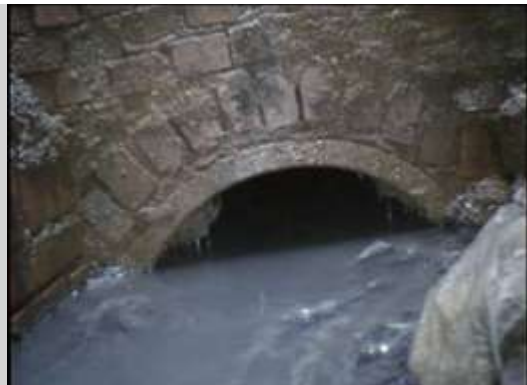
6 O'Clock Inflow

24 in. Circular Gravity Sewer
Pipe In @ 6 O'Clock

Pipe Height: **12** (in.) Rod and Bar (Angled)
Pipe Material: **Clay** ☐ Pipe Lined
Invert Depth: **15.20** (ft.) Flow Characteristics: **Slow**
Deposits: ☐ None ☐ Mud ☒ **Sludge** ☒ **Debris** ☐ Grease
Silt Depth: **14** (in.) Deposits Extent: **Heavy**
Infiltration: **None** Pipe Seal Cond: **Sound**
